DEPARTMENT OF CIVIL AVIATION

**FINAL
INVESTIGATION
REPORT**

**ACCIDENT OF
MICROLIGHT AIRCRAFT
3B-WWI,
ON 24 FEBRUARY 2023**

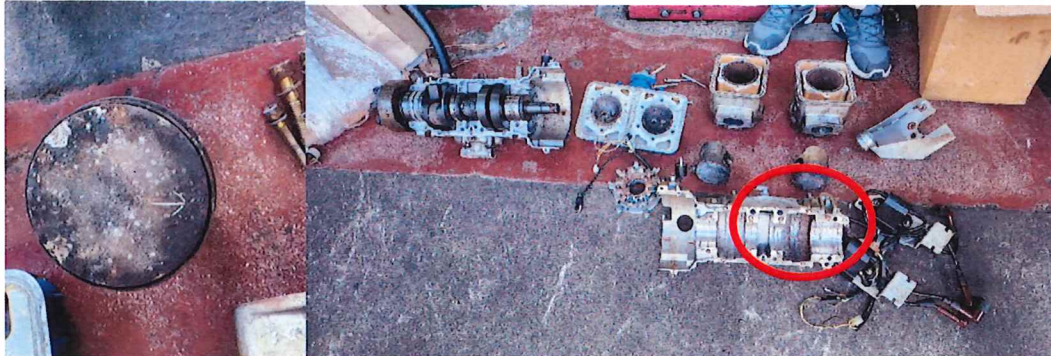
Engine has been investigated at the garage in charge of the disassembling and it was observed that the Piston Head was burned due to overheated conditions and also the crankcase damaged by the abnormal friction of the crankshaft. Both observed damages are due to a lack of lubrication.

Based on this information, it can be concluded that the accident occurred due to inappropriate lubrication following the unusual quality of engine oil used, leading to engine overheating and consequently, engine seizure and emergency landing on the lagoon.

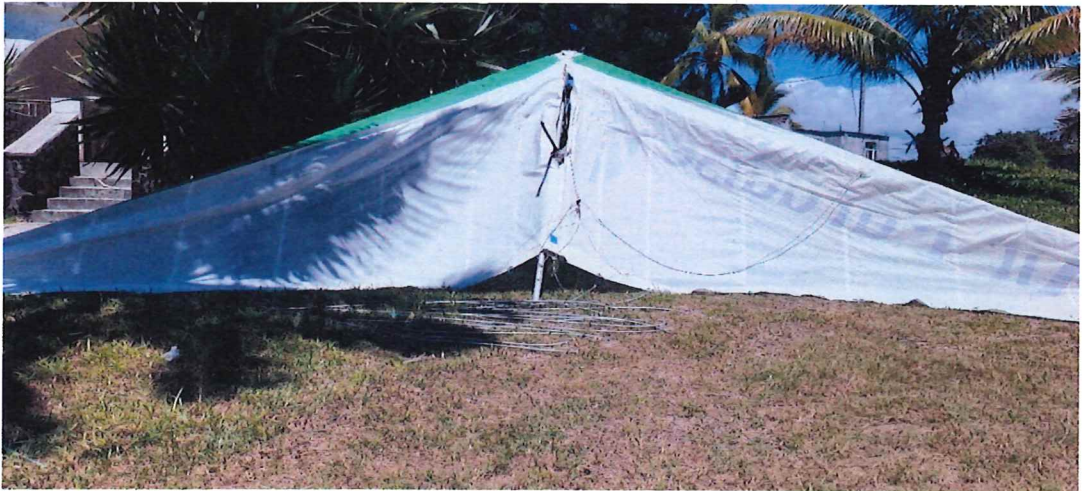
6.3 Wing

After the emergency landing, all components of the Microlight Aircraft were serviceable. It was after the capsizing of the Microlight that the wing were damaged as shown at [6.3](#), [6.4](#) and [6.5](#).

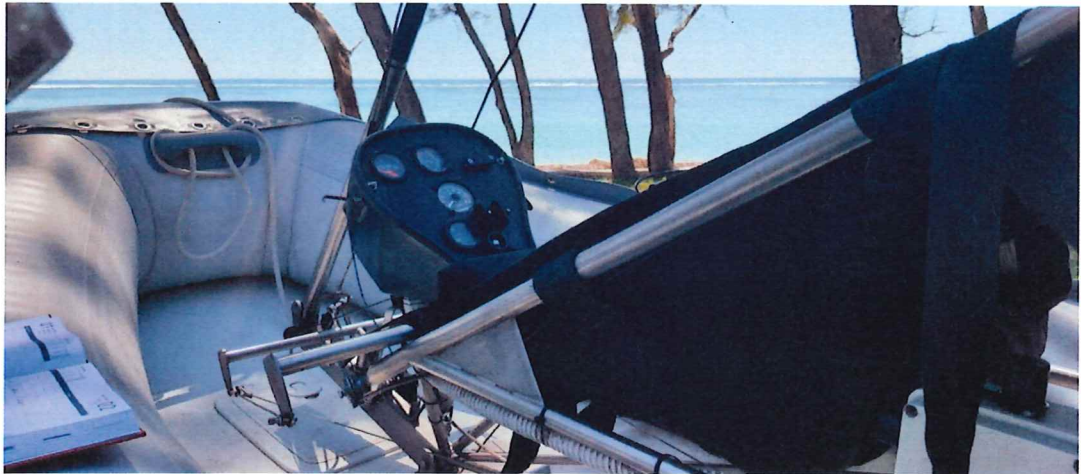
6.8 Engine instruments console

Please note that since this is a two-stroke engine, there is no oil pressure or oil temperature gauge.

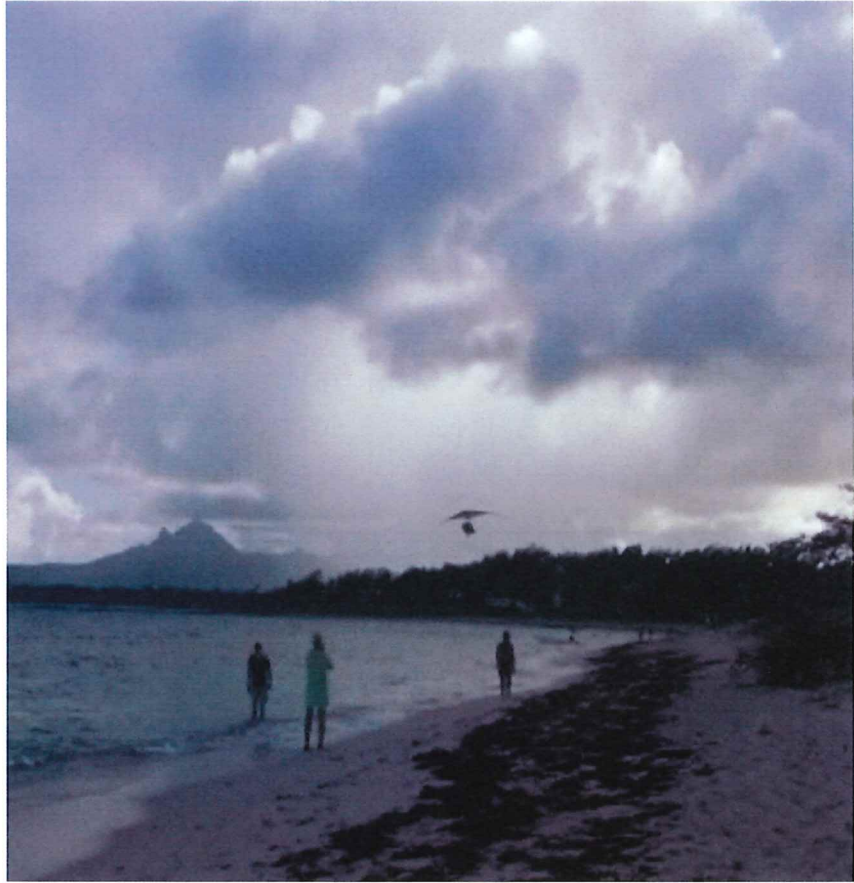
The complaints mentioned that the same day of the accident, Air Paradise was flying at an altitude of 50 - 70 feet over the beach of Palmar creating high disturbing noise over the area and it was also noted that the taxiing procedures was not applied (Take off and landing close to the beach)

6.9 Low altitude flight over the beach

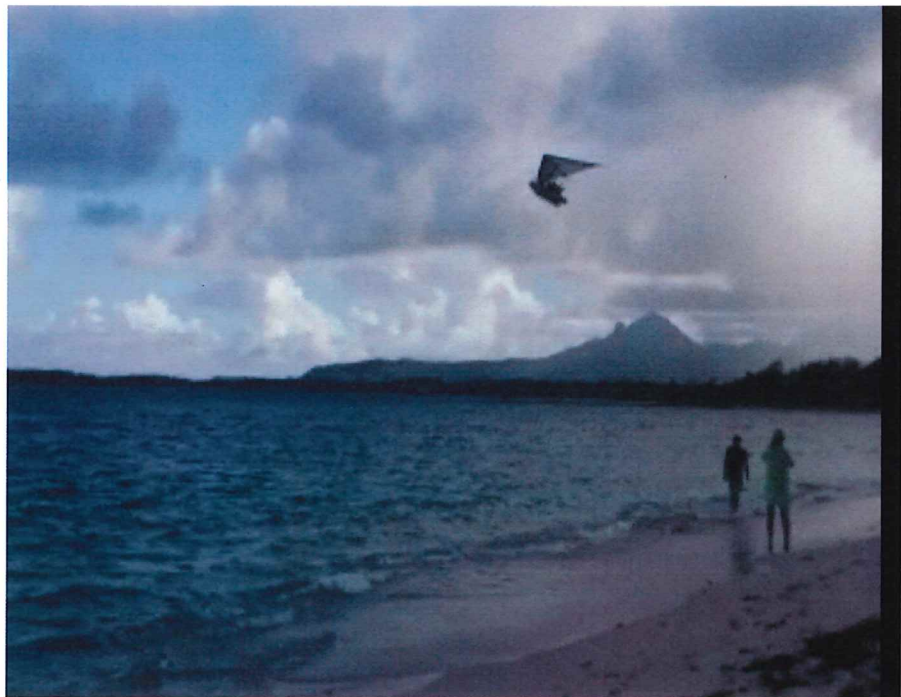
6.10 Aerobatic very noisy recovery over the Palmar beach
