DEPARTMENT OF CIVIL AVIATION

**FINAL
INVESTIGATION
REPORT**

**TCAS RA INCIDENT OF
MAU293 (A330/243) and
REU 121 (B777-39/M(ER))
AIRCRAFT,
ON 3 JANUARY 2024**

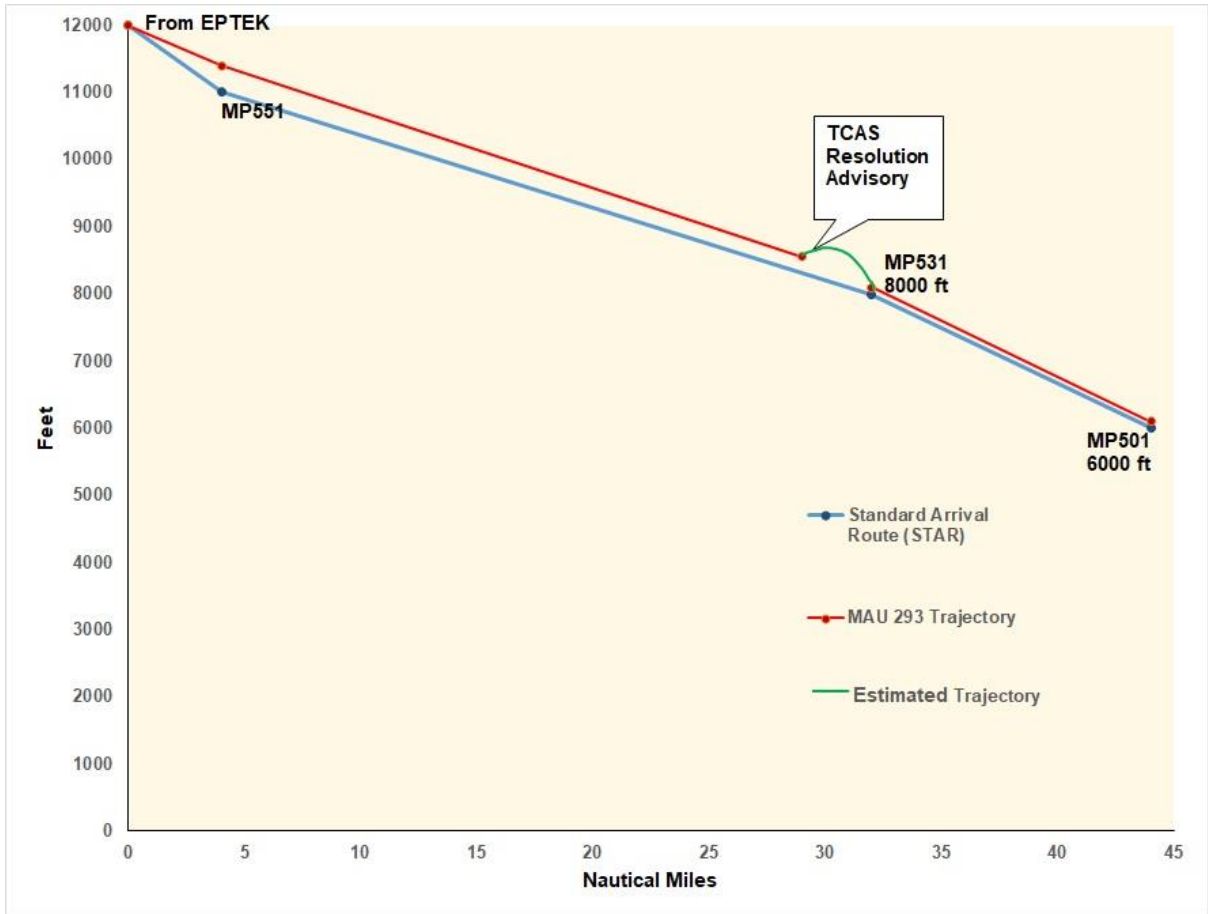
6.1 Appendix 1 – MAU 293 Trajectory on STAR

- Air Mauritius had followed the STAR for approach RWY 32 as per the published AIP, cleared by the approach controller without being aware of the departing aircraft. The reproduction of the exact time of the TCAS RA event clearly showed that the PF reacted promptly changing in climbing asset as per TCAS instruction. Further analysis also showed a normal recovery to the STAR procedures after the event.
- The analysis of the Data recorder also allowed to draft the estimated trajectory of the Air Mauritius A330 aircraft as shown in Appendix 1.

- 1) The crew of Air Mauritius MAU 293 complied fully with the trajectories, waypoints and reference levels of the published chart "Standard Arrival Route" Reference AD2-FIMP 37.2. The only deviation from the descent profile occurred at the time of the AIRPROX event, when the Pilot in Command (PF) deviated manually upward. The crew resumed control of the aircraft after the event, returning it to its initial descent path. (see MAU 293 flight profile in annex 1)

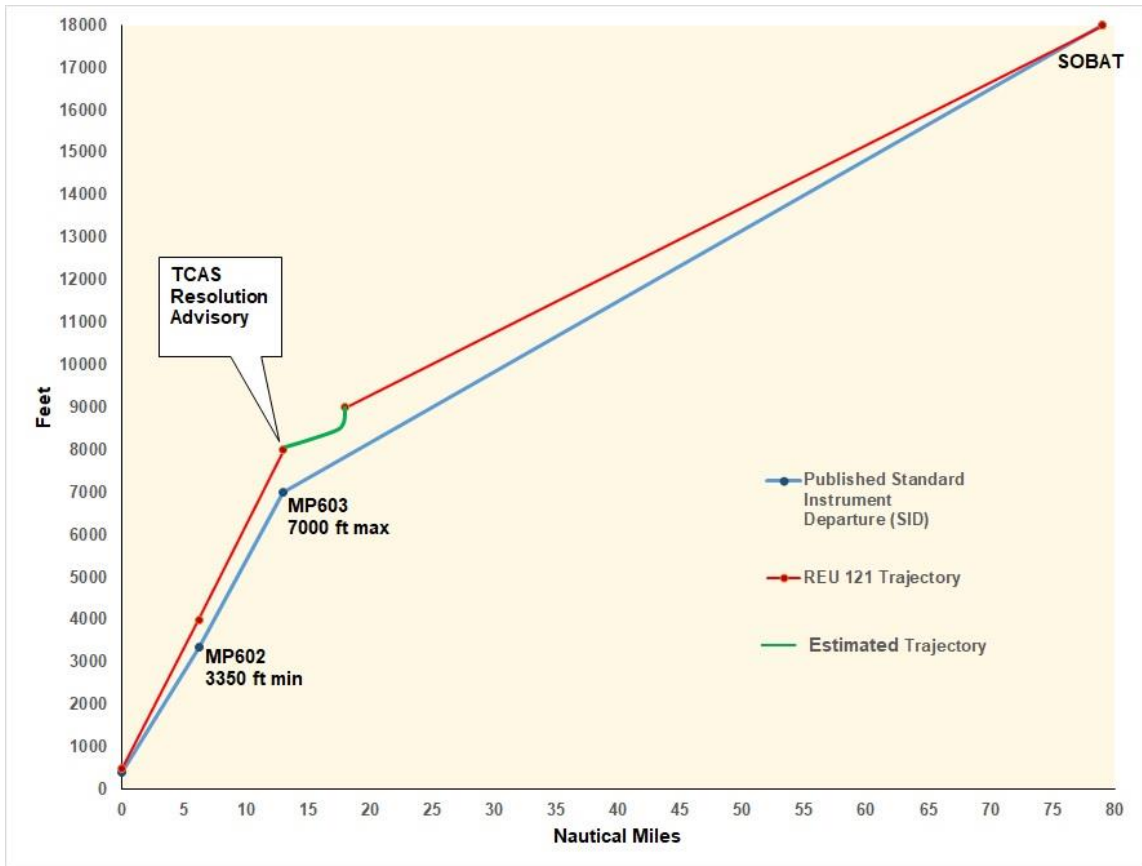
6.2 Appendix 2 – REU 121

- 2) With regard to Air Austral flight REU 121, it should be noted that the flight's parameters and FDR data were not available. However, according to ATC and flight trajectory data, it is clear that the crew of REU 121 did not comply with the procedure published constraints in the "Standard Departure Chart - Instrument" reference AD2 -FIMP-35.2 (SOBAT TWO Bravo Departure). The Boeing was at waypoint MP 603 at flight level 080 when it should not have been flying above flight level 070 over this waypoint, hence the proximity alert with the Air Mauritius flight descending in the same area between flight level 100 and flight level 060. (see REU 121 Flight profile in annex 2)
