DEPARTMENT OF CIVIL AVIATION

**FINAL
INVESTIGATION
REPORT**

**ACCIDENT OF
MICROLIGHT AIRCRAFT
3B-WWI,
ON 24 FEBRUARY 2023**

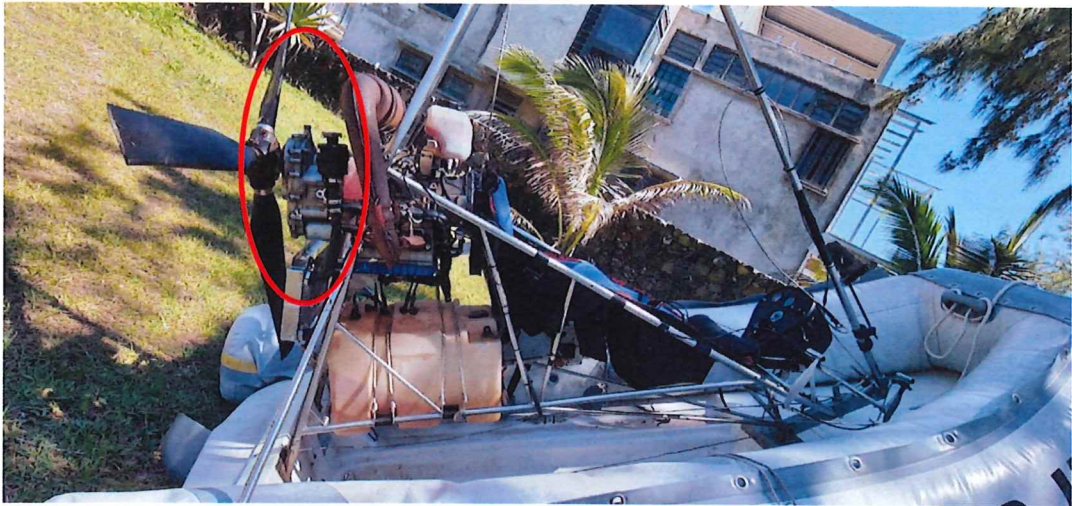
6.8 Engine instruments console

- RPM Indicator (Revolutions per minute)
- EGT Indicator (Exhaust Gas Temperature)
- Cylinder Head Temperature gauge
- Timer

Please note that since this is a two-stroke engine, there is no oil pressure or oil temperature gauge.

1. The change of Oil brand has affected the lubrication of the engine due to difference of grade of viscosity.
2. Inaccurate Monitoring of oil temperature and pressure inaccurate.
3. Defective cooling system.
4. Intensive operations + limit / overload mass & balance conditions – short cruise (short cooling conditions)
